RIELLO INFORMS YOU

Engineering & Service _02_2021

Product Advisory

Array HMI Screen:

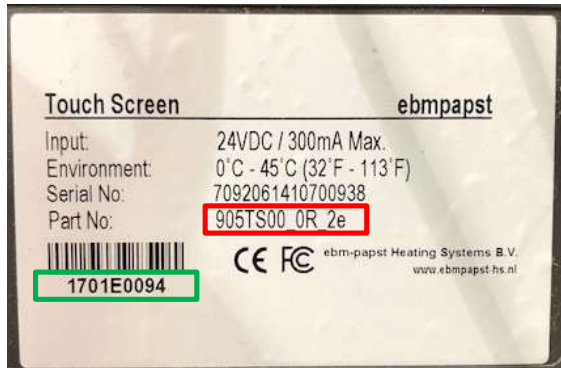
Fig. 1 HMI screen label - Type highlighted red, barcode green

Step 2: Identify the Touchscreen type, Fig. 1

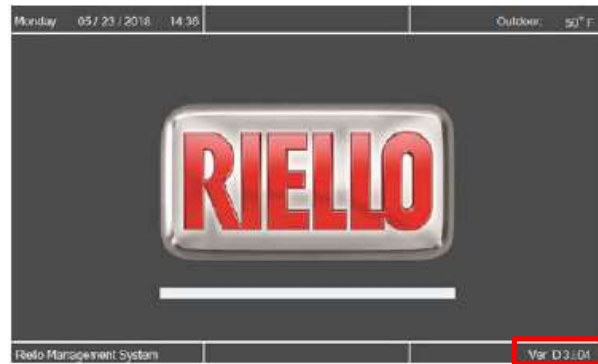
Fig. 2 HMI home screen - Version highlighted

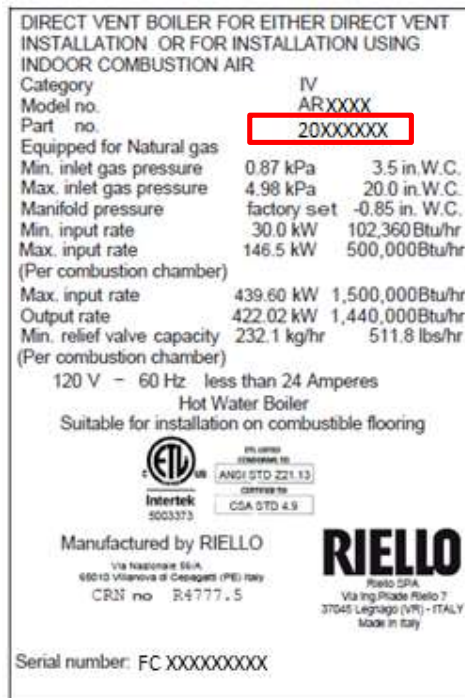
Fig. 3 - Array nameplate

Step 1: Identify the ARRAY Boiler Product type from the nameplate label, Fig. 3
